# **Certificate of Testing**

Da	ate:			
Syste	em: (	Corian Rainsc	reen	
System suppli		DuPont de Nemou 2, chemin du Pavil Le Grand-Saconne CH-1218 Geneva Switzerland		
Tests perform	ed:			
	,	Watertightness -	- dynamic	✓
	,	Wind resistance	- serviceability	✓
	,	Wind resistance - safety		✓
		Soft body impac	t	✓
In accordance with 'S	tandard	for Systemised b	ouilding envelopes C'	WCT, 2006
Signed: .			Test Witness	
Signed .			Director

### **Description of components tested**

Rainscreen system: **Dupont Corian**

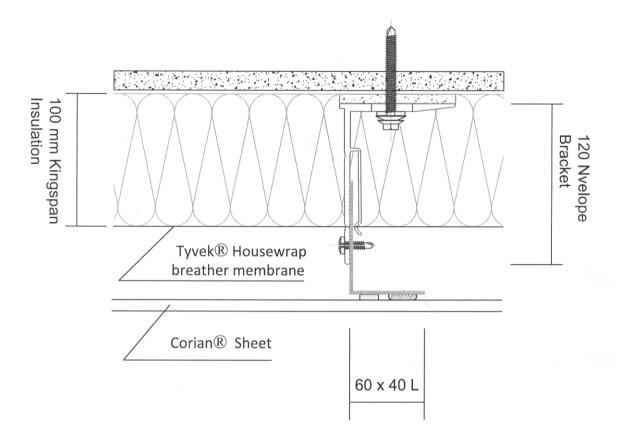
Horizontal section through Nvelope NV2 support system with panel bonded to rail using Sika Tack system.

Nvelope NV2 system comprising vertical rails fixed to back wall with aluminium brackets at 625 mm

Panels fixed to vertical rails with continuous

bead of Sika tack adhesive

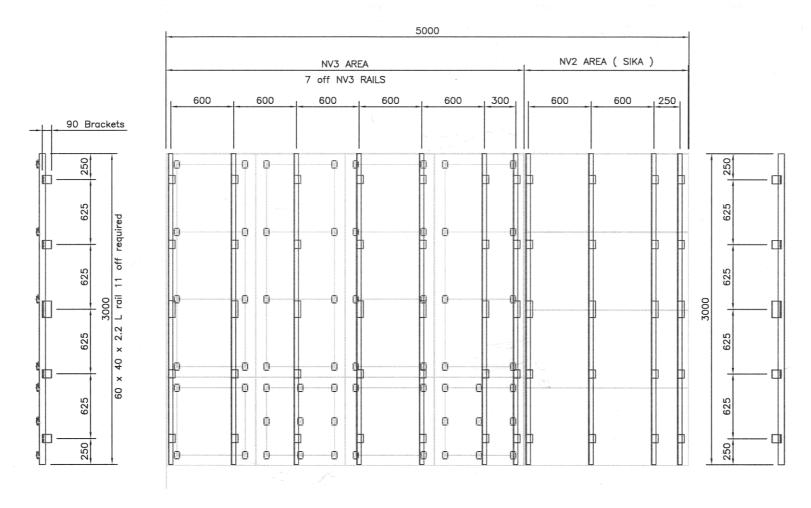
Elevation of wall showing support rails (centre). Vertical section to left of elevation shows area with mechanically clipped panels and horizontal rails. Vertical section to right of elevation shows area with bonded panels which does not require horizontal rails

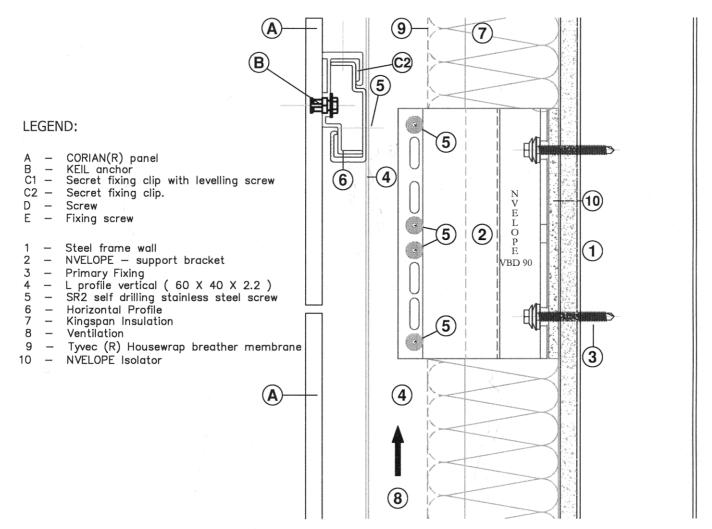
Vertical section through Nvelope NV3 support system. Figure shows fixed point bracket, rails fixed to bracket at moving point using slotted holes. The top clip on the panel was provided with levelling screw

Support system: Nvelope NV3 system

Vertical aluminium rails at 600mm centres fixed to back wall with aluminium brackets at

625mm spacing. Horizontal rails at 650mm centres screwed to vertical

Fixings: Nvelope NV3 clips

attached to back face of panel by Keil
